WEEKLY STATUS REPORT

BCP Project No.:	C224099	EPA Consent Order No.:	CERCLA-02-2017-2021	Date:	08/19/2019
Project Name:	BRT Powerhouse 153 2 nd Street AKA 322 3 rd Avenue, Brooklyn, NY 11215				
Remediation Activities (Week of August 12, 2019): <ul style="list-style-type: none">Continued gauging and product recovery via absorbent sock as necessary.					
Redevelopment Activities (Week of August 12, 2019): <ul style="list-style-type: none">Maspeth Welding (Site steel contractor) continued steel repair work in the turbine hall.Northeast Demolition (Site demolition contractor) continued demolition work in the turbine hall.Continued general site maintenance.Continued site surveying work as necessary.Structure Tech (Site contractor) completed test pit excavation to locate the historical coal tunnel west of the boiler house slab for hoist pad installation development.Structure Tech began excavating the geotechnical test pits at the northeast and southeast corners of the boiler house slab and in the south Site driveway. Excavated soil was stockpiled adjacent to the test pits and groundwater from the test pits was pumped through the treatment system and into the holding tanks. Roux collect

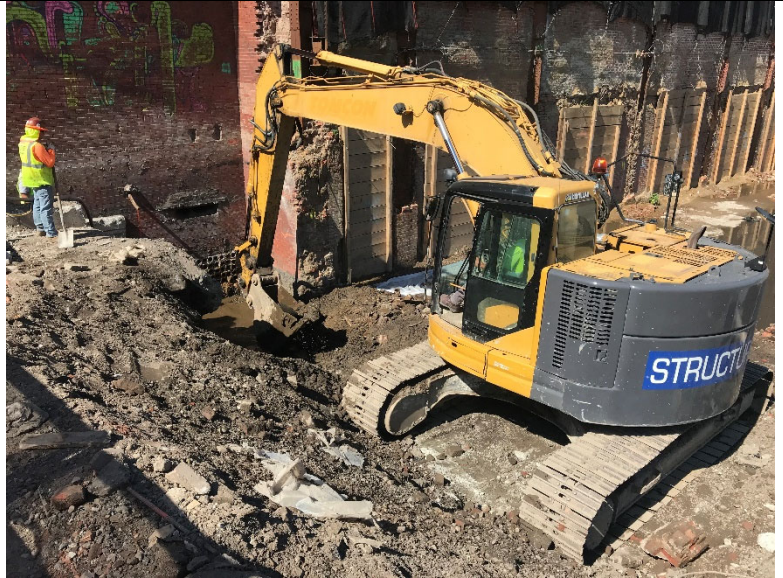
Photo 1 – Looking southwest at the boiler house slab. Structure Tech excavates the geotechnical test pit to inspect the timber piles under the mat slab.

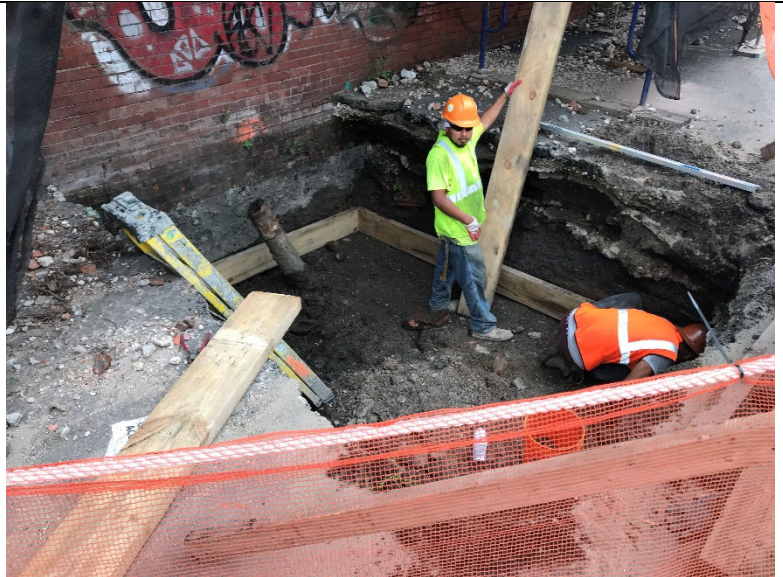
Photo 2 – Looking north in the south Site driveway. Structure Tech installs shoring at the geotechnical test pit located south of turbine hall.

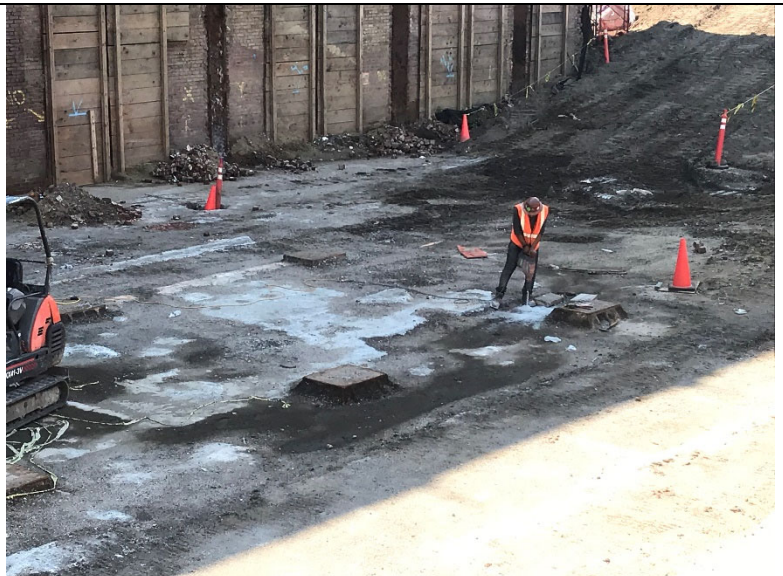
Photo 3 – Looking southwest at the boiler house slab. Structure Tech drills for rebar installation related to the pull-tests.
